RE: ASARCO East Helena Smelter, Transmittal of EPA Inspection
Report for Corrective Action Assessment Inspection, September 8, 2006

**U.S. EPA REGION VIII
TECHNICAL ENFORCEMENT PROGRAM
RCRA COMPLIANCE INSPECTION REPORT**

Facility: ASARCO East Helena Plant
100 Smelter Road
East Helena, MT

Inspection Type: Corrective Action Assessment Inspection

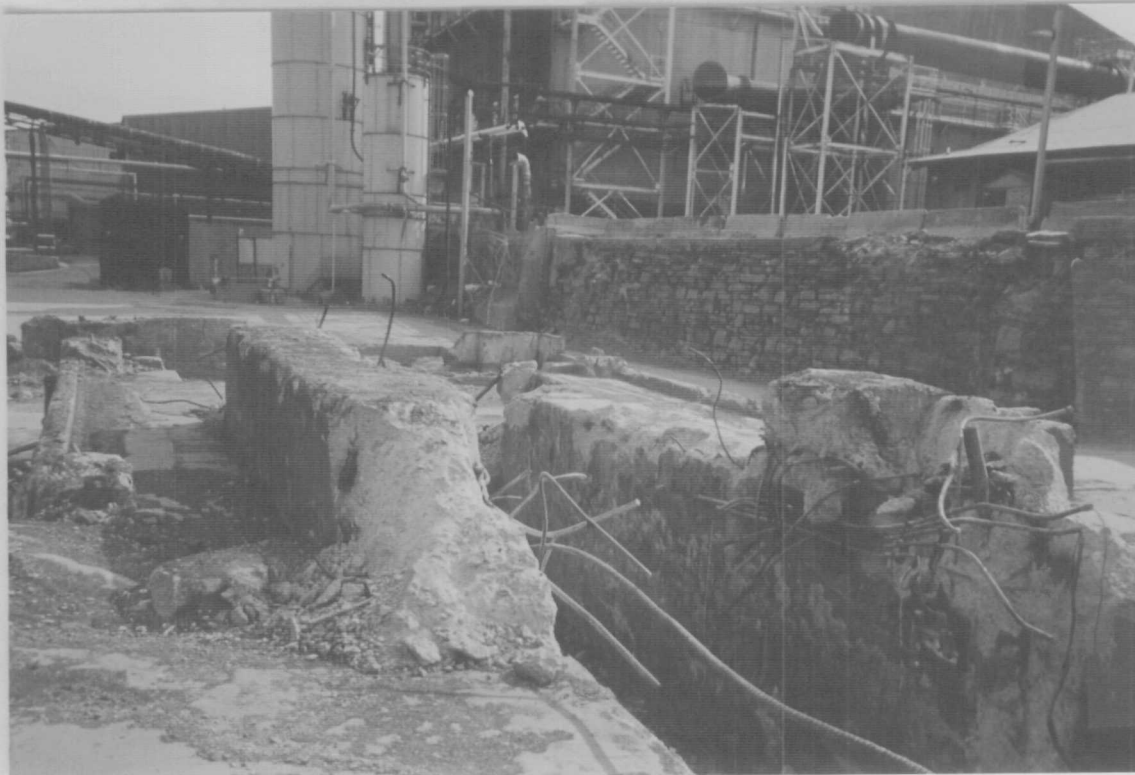
Roll 2, Photo 9; Facility: ASARCO East Helena Smelter; Subject: Former Sinter Plant Foundation; Photographer: Linda Jacobson; Date: September 8, 2006

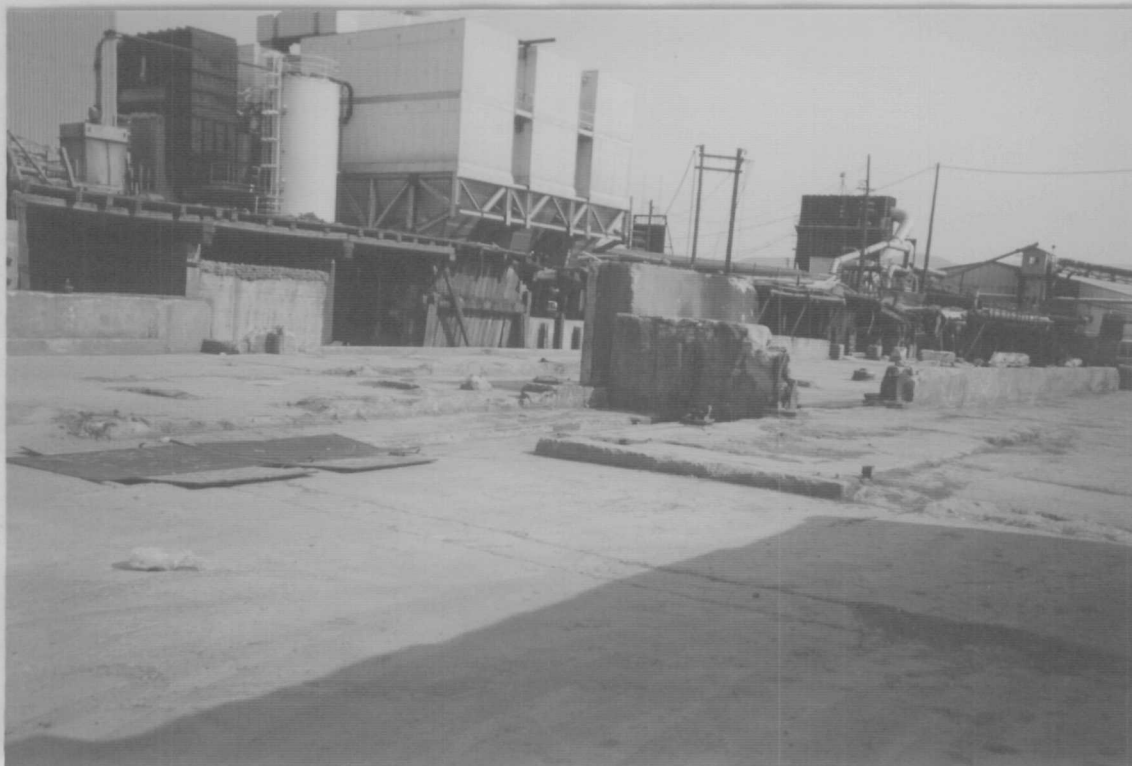
Roll 2, Photo 10; Facility: ASARCO East Helena Smelter; Subject: Foundation of Former Sinter Plant; Photographer: Linda Jacobson; Date: September 8, 2006

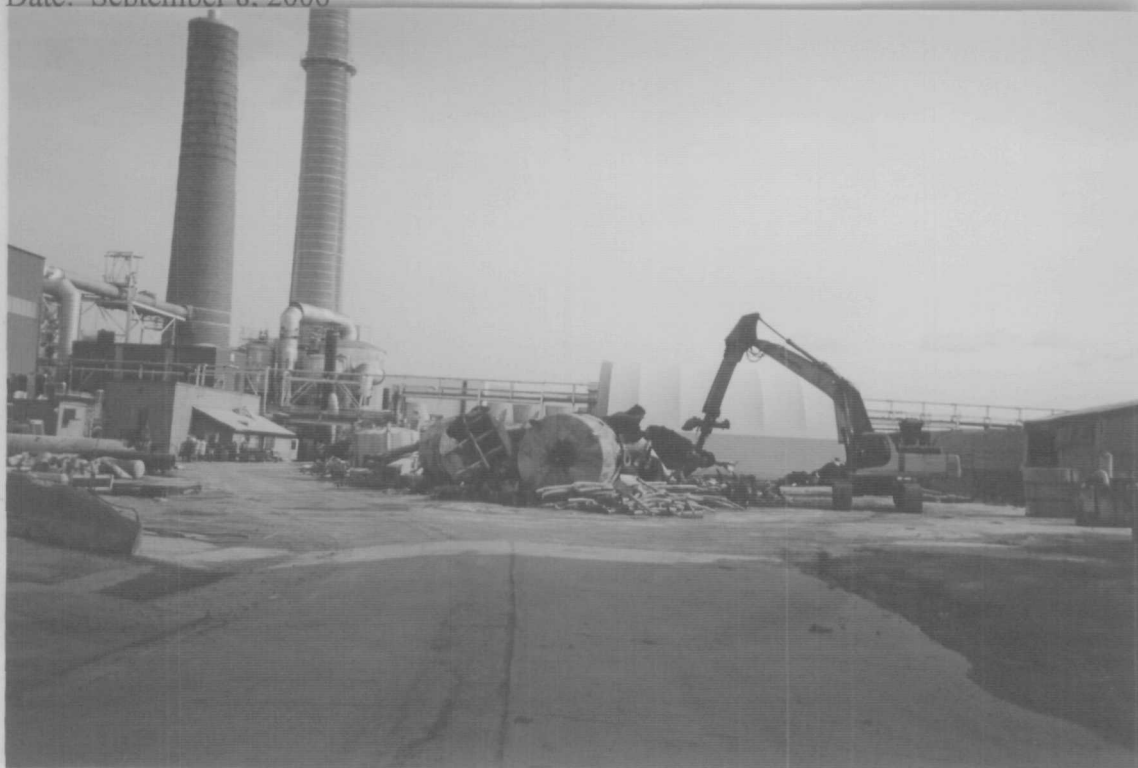
Roll 2, Photo 12; Facility: ASARCO East Helena Smelter; Subject: Demolition Work
Proceeding; Photographer: Linda Jacobson; Date: September 8, 2006

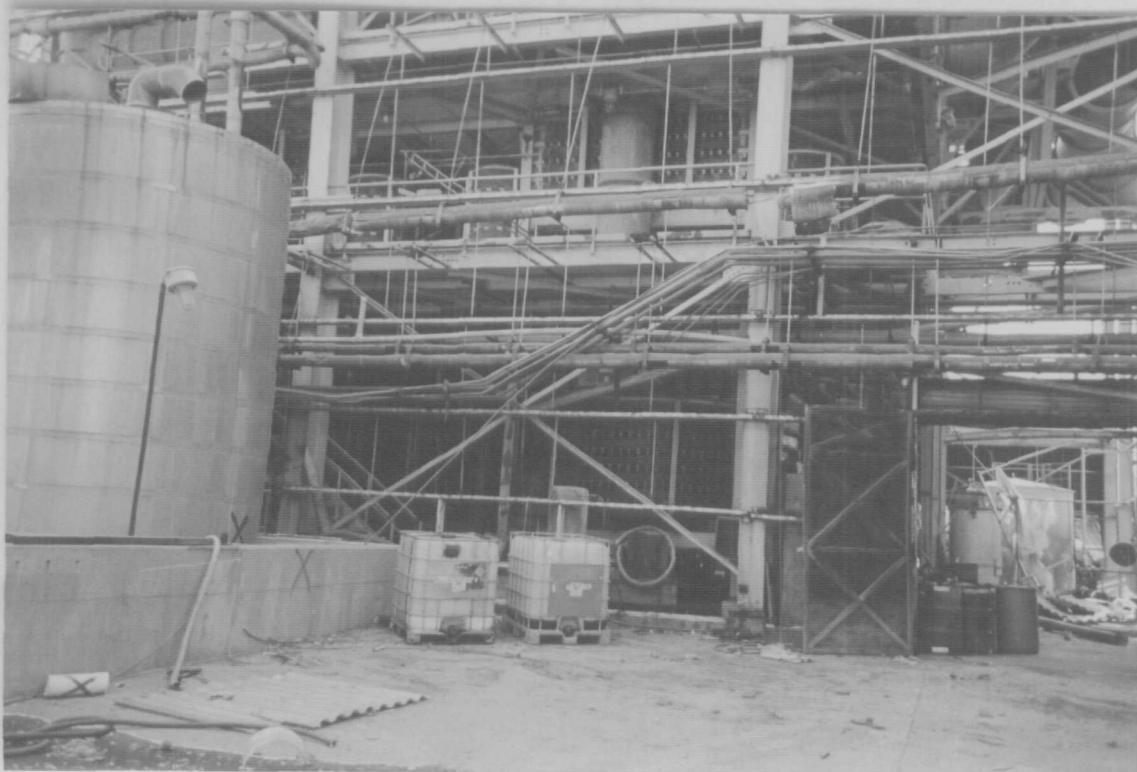
Roll 2, Photo 16; Facility: ASARCO East Helena Smelter; Subject: Structures to Be Demolished in Next Phase; Photographer: Linda Jacobson; Date: September 8, 2006

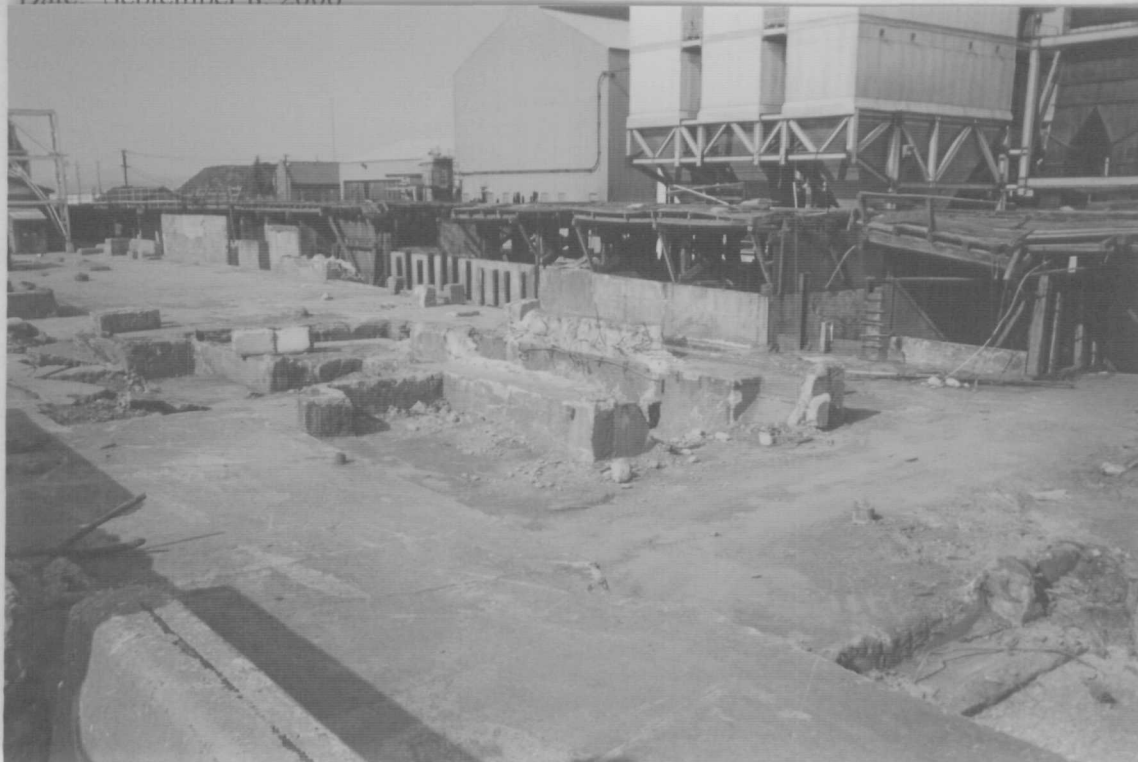
Roll 2, Photo 18; Facility: ASARCO East Helena Smelter; Subject: Former Sinter Plant Foundation; Photographer: Linda Jacobson; Date: September 8, 2006

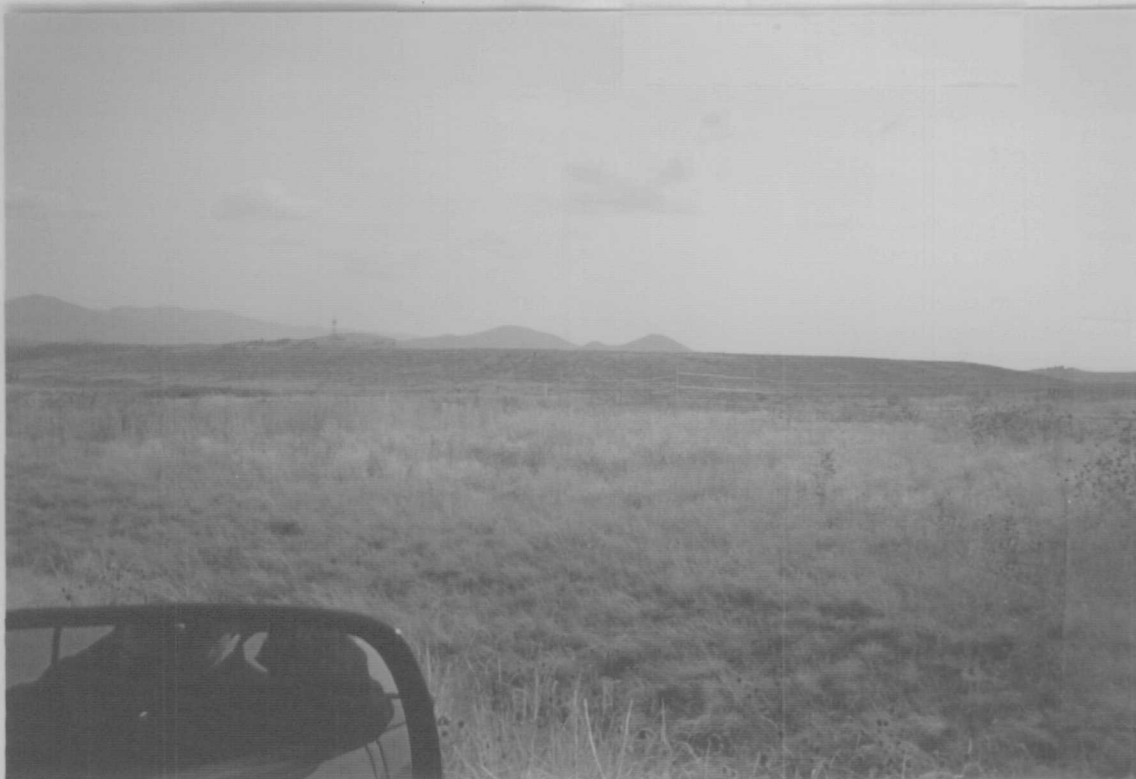
Roll 2, Photo 19; Facility: ASARCO East Helena Smelter; Subject: Location of CAMU Cell 2;
Photographer: Linda Jacobson; Date: September 8, 2006

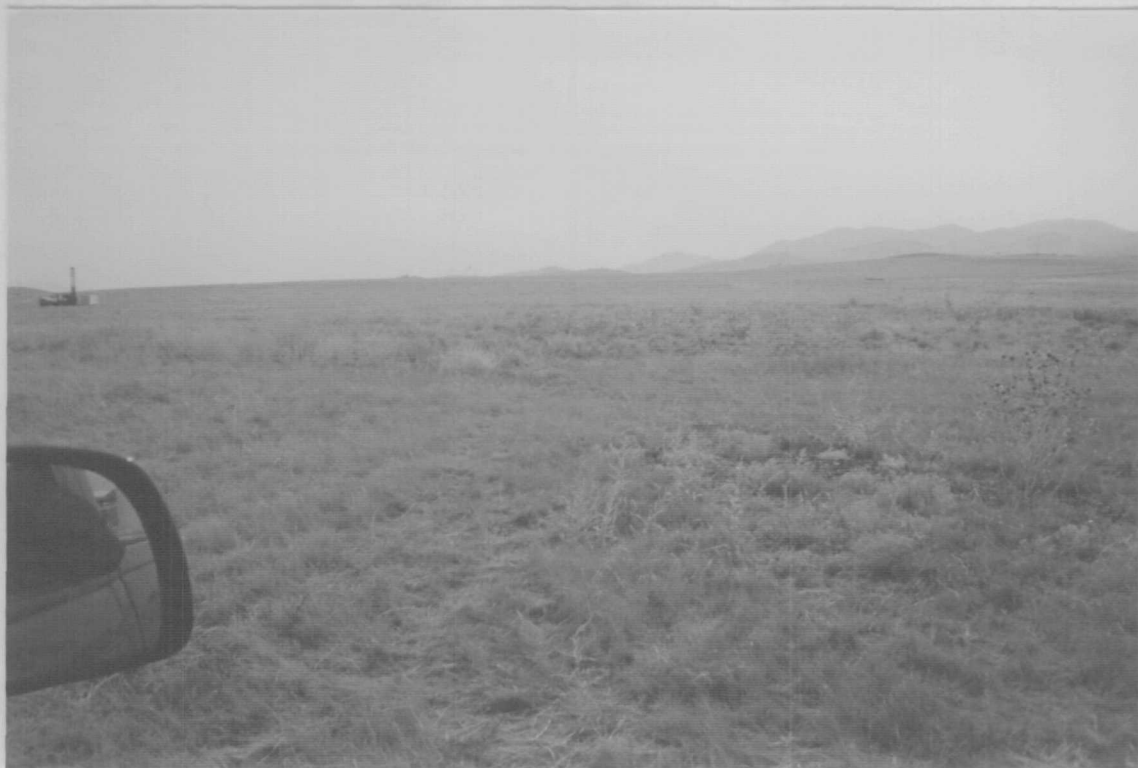
Roll 2, Photo 20; Facility: ASARCO East Helena Smelter; Subject: Location of CAMU Cell 2;
Photographer: Linda Jacobson; Date: September 8, 2006

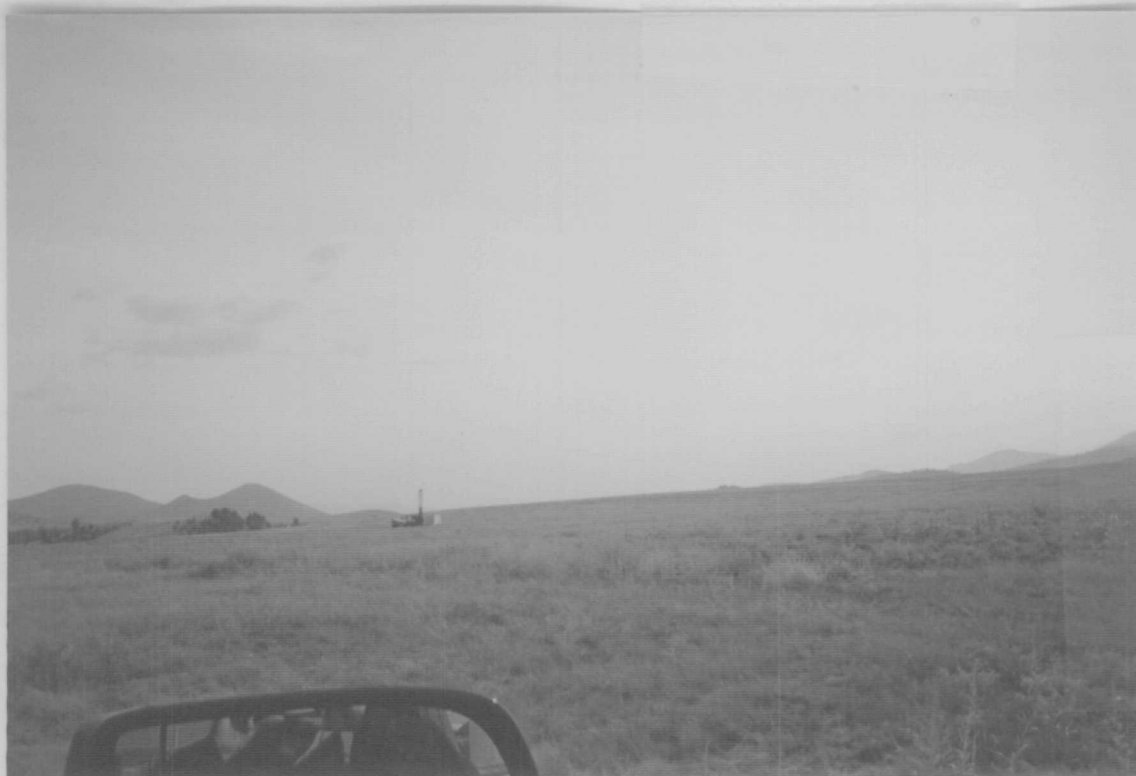
Roll 2, Photo 21; Facility: ASARCO East Helena Smelter; Subject: Location of CAMU Cell 2; Photographer: Linda Jacobson; Date: September 8, 2006

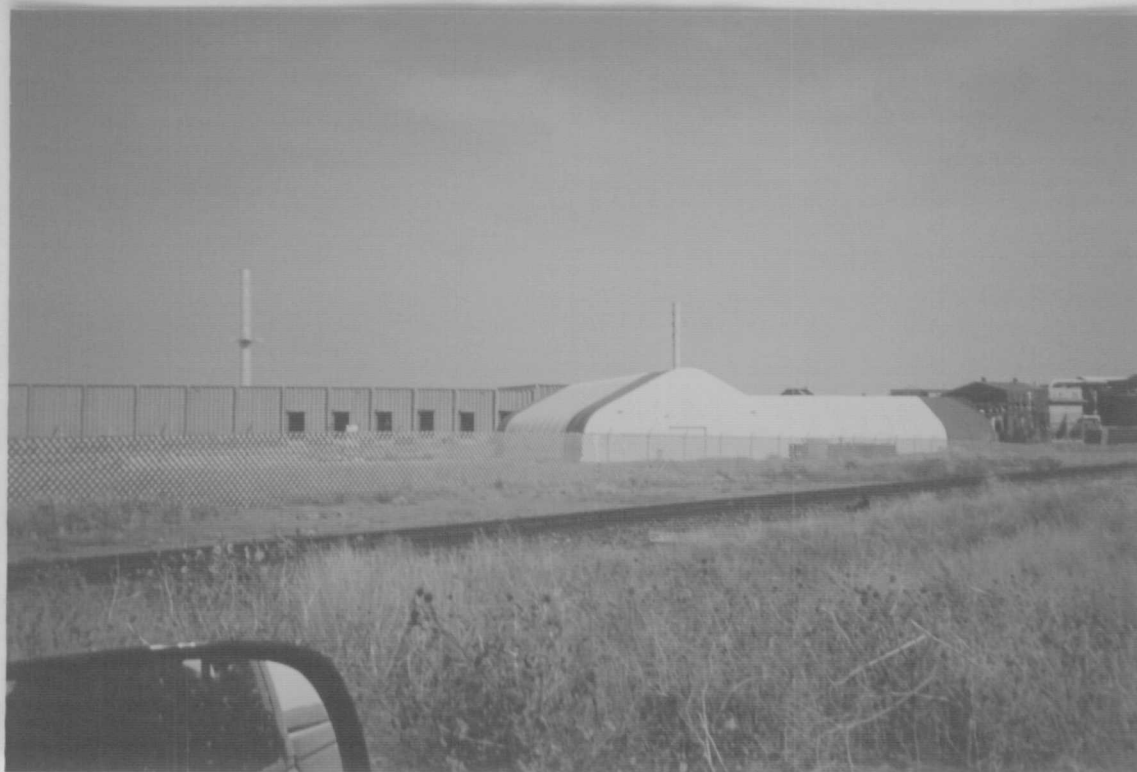
Roll 2, Photo 22; Facility: ASARCO East Helena Smelter; Subject: ASARCO Storage Buildings; Photographer: Linda Jacobson; Date: September 8, 2006

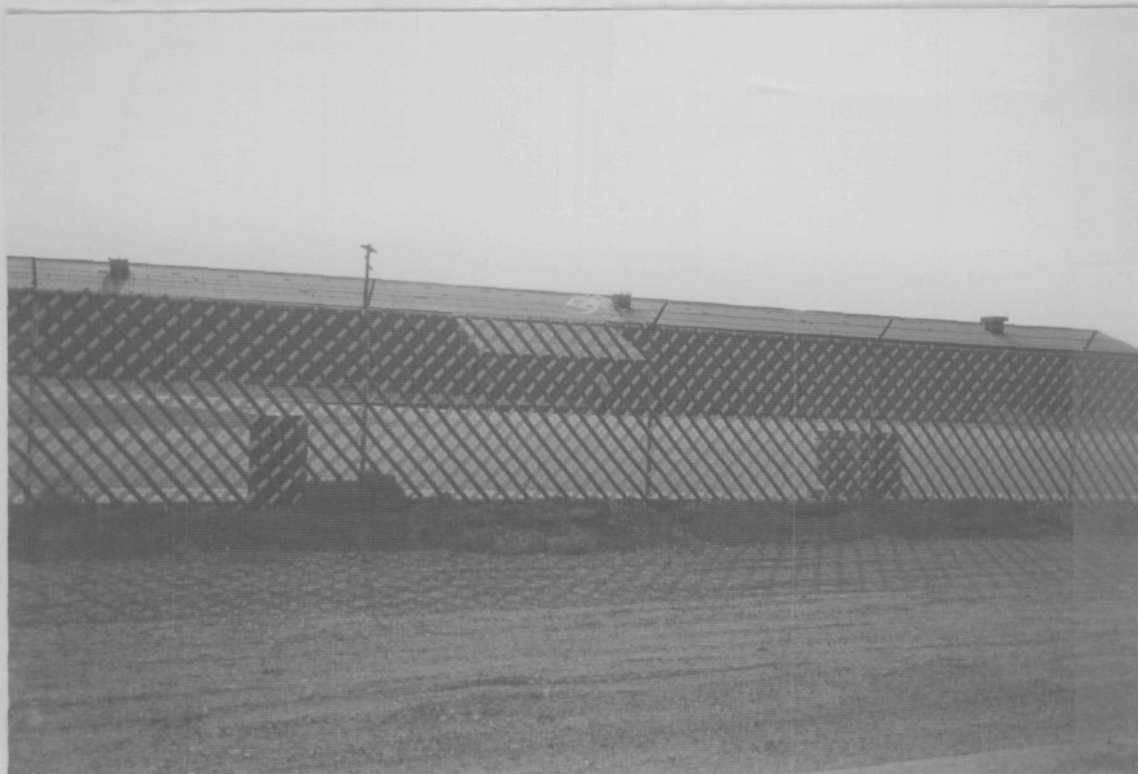
Roll 2, Photo 23; Facility: ASARCO East Helena Smelter; Subject: New PRB Well to West; Photographer: Linda Jacobson; Date: September 8, 2006

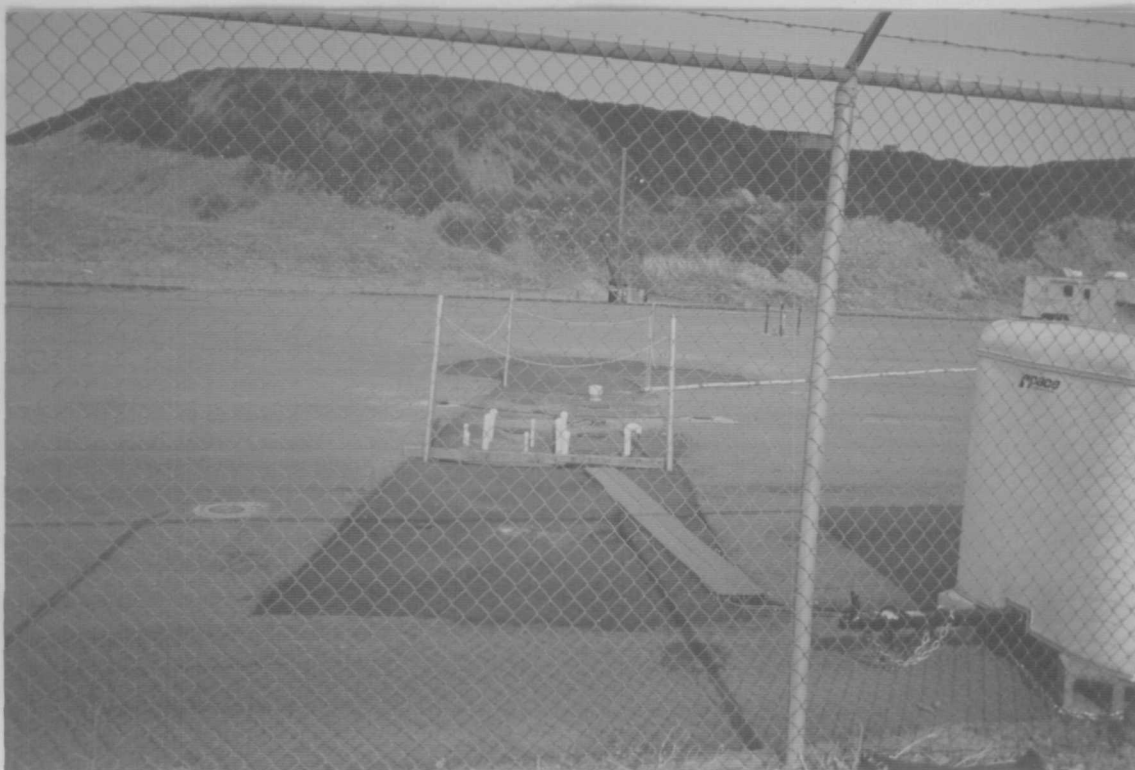
Roll 2, Photo 24; Facility: ASARCO East Helena Smelter; Subject: Existing and New PRB Wells; Photographer: Linda Jacobson; Date: September 8, 2006

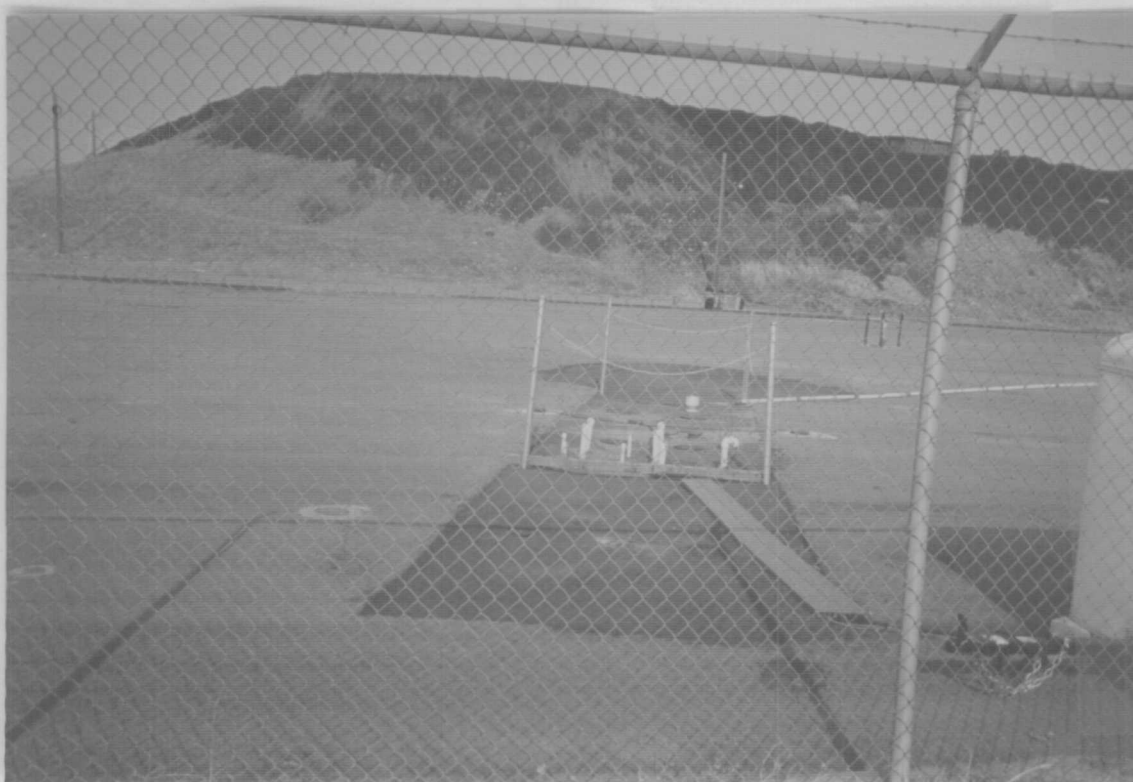
Roll 2, Photo 25; Facility: ASARCO East Helena Smelter; Subject: Existing and New PRB Wells; Photographer: Linda Jacobson; Date: September 8, 2006

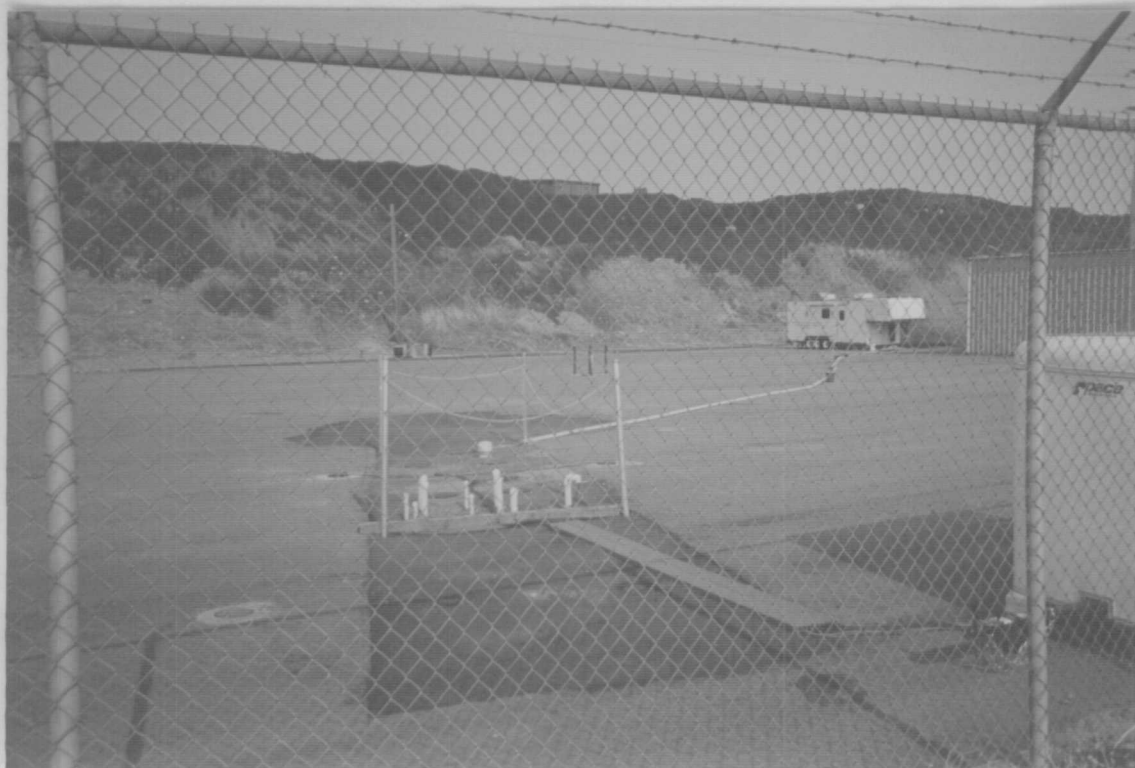
Roll 2, Photo 26; Facility: ASARCO East Helena Smelter; Subject: Pilot-Scale PRB Wall Location; Photographer: Linda Jacobson; Date: September 8, 2006

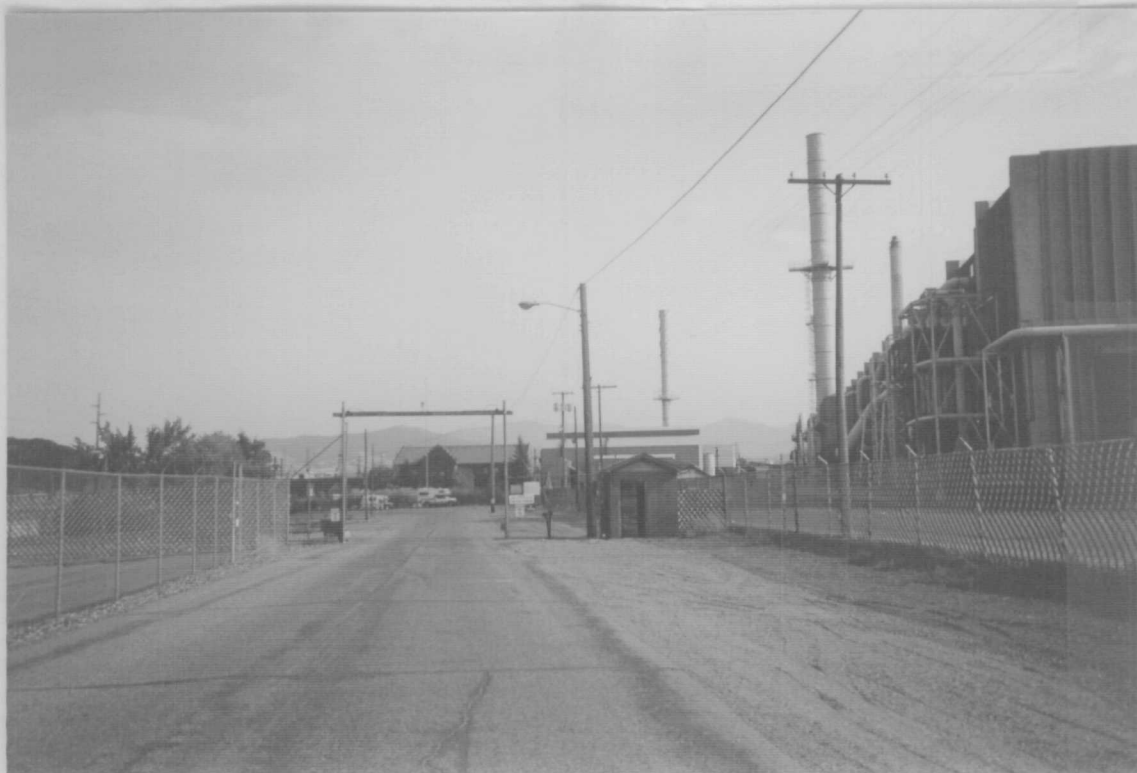
Roll 2, Photo 27; Facility: ASARCO East Helena Smelter; Subject: ASARCO Facility;
Photographer: Linda Jacobson; Date: September 8, 2006
